Rosetta[®]

Troubleshooting Guide

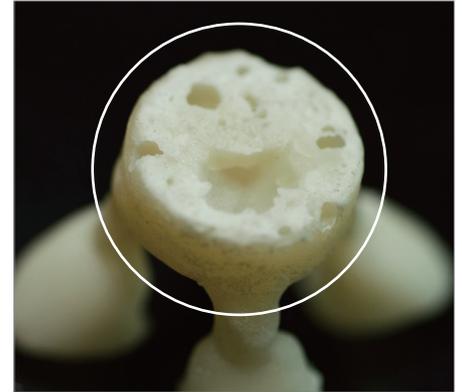
Case 1 Pores after pressing

Pores occurred on the surface of rest of restoration after pressing.

When ingot is pressed at a higher temperature than the recommended temperature, the surface boils and causes porosity.

- Press to fit the recommended temperature on the pressing schedule table.
- If recommended temperature schedule has been applied, check the calibration of the pressing furnace.
If calibration is difficult, decrease the pressing temperature by 10°C lower than the recommended temperature.
- Shorten the holding time.
- Pressing at an overheated temperature may result in porosity and thick reaction layers on the ingot surface.

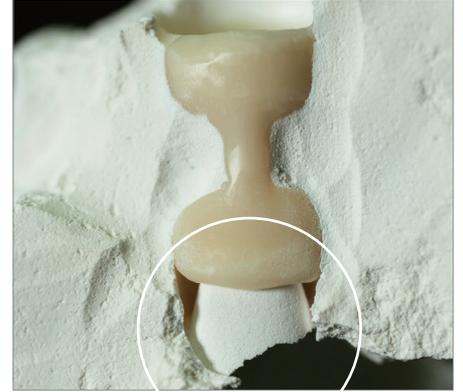
Case 2 Insufficient pressing not as much as wax pattern

Ingot has not been melted enough into the margin part.

- This problem happens when ingot has not been crystallized well at the optimal temperature.
- Pressing temperature is low.

- Press to fit the recommended temperature schedule table. (Please refer to the Rosetta® SP Pressing Schedule)
- If recommended temperature schedule has been applied, check the calibration of the pressing furnace. If calibration is difficult, decrease the pressing temperature by 10°C lower than the recommended temperature.
- Make sure there is sufficient hardening of the investment material so that it does not crack while working and do not apply any impacts or shocking. The ingot may not be pressed properly when the investment material is cracked.

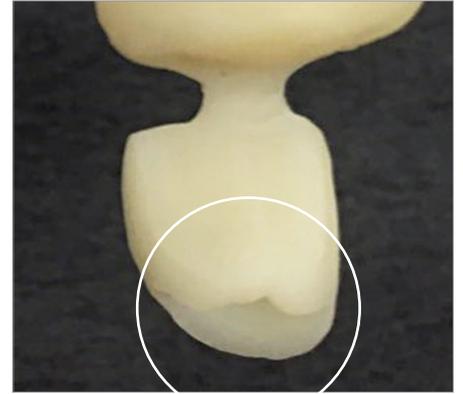
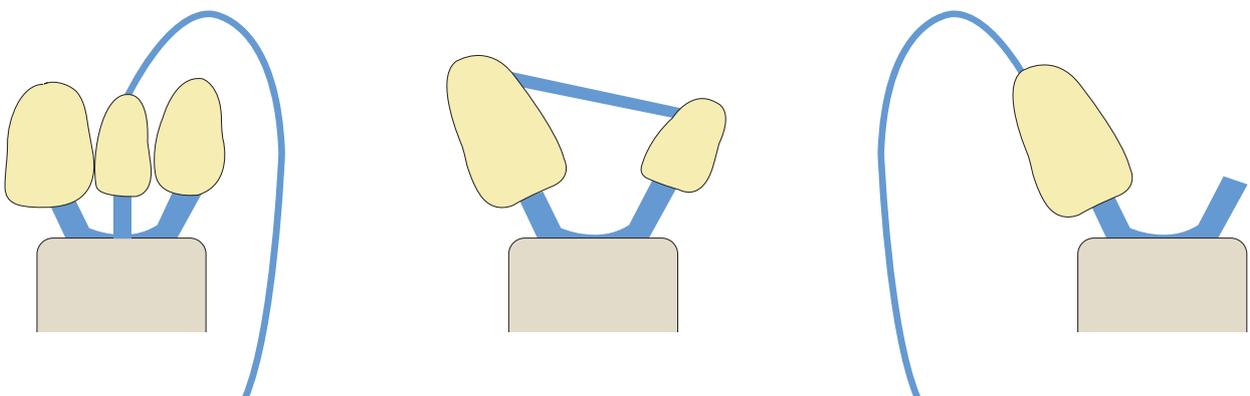
Case 3 Insufficient pressing not long enough to the margin part

Ingot was not pressed long enough to the margin part.

- 1) The residual gas may exist inside due to insufficient holding time for wax burnout.
- 2) The sprue may be fixed in an inappropriate way while setting the wax sprue.

- Take sufficient holding time in burnout process. At least one hour is recommended. Or residual gas may interfere with appropriate processing.
- Follow the time table recommended by investment material manufacturer.
- Observe below guidelines when you work on wax sprue.
- When press body is large, add air vent to reduce internal pressure generated by pressing.
- In case of applying more than two press body and/or when there is height gap between press bodies, add sprue between the bodies.

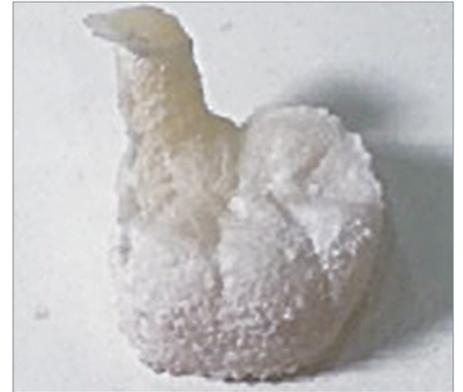
Case 4 Too many reaction layers

Too many reaction layers remain roughly on the surface after divesting.

- 1) Due to overheating pressing temperature or overlong holding time.
- 2) The residual gas may exist inside due to insufficient holding time for wax burn out.

- Press to fit the recommended temperature schedule table.
- If recommended temperature schedule has been applied, Check the calibration of the pressing furnace.
If calibration is difficult, decrease the pressing temperature by 10°C lower than the recommended temperature.
- The reaction layers may be formed due to the residual gas inside, so please proceed with sufficient burnout holding time.
- Do not reuse any ingot.
- Observe the mixing ratio recommended by investment material manufacturer.
- Use the investment material which generates less reaction layers.

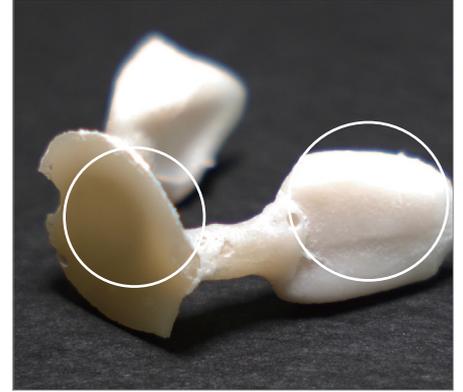
Case 5 Discoloration or two colors after pressing

Discoloration or two colors appears after pressing.

- 1) Due to the higher pressing temperature than the recommended temperature.
- 2) Due to reuse ingot.

- Press to fit the recommended temperature schedule table.
- If recommended temperature schedule has been applied, check the calibration of the pressing furnace.
If calibration is difficult, decrease the pressing temperature by 10°C lower than the recommended temperature.
- Do not reuse any ingot. If reused, the results may come out in different colors from its original shade.

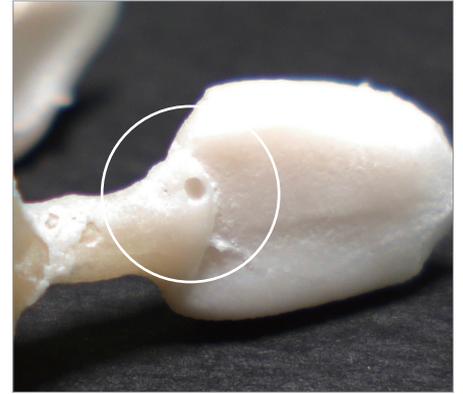
Case 6 Formation of bubble and excessive reaction layers

There are pores and excessive reaction layers on the surface after pressing.

Insufficient amount of ingot causes unstable pressing work and the consequent lack of pressure results in gas porosity.

- Check the weight of wax pattern as below to make sure the ingot weight is enough to press.
(R10 1ea up to 0.7g, R20 1ea up to 1.7g)
- Do not reuse any ingot.
- Check the pressure of the compressor in use.
- Get rid of moisture in the tank.

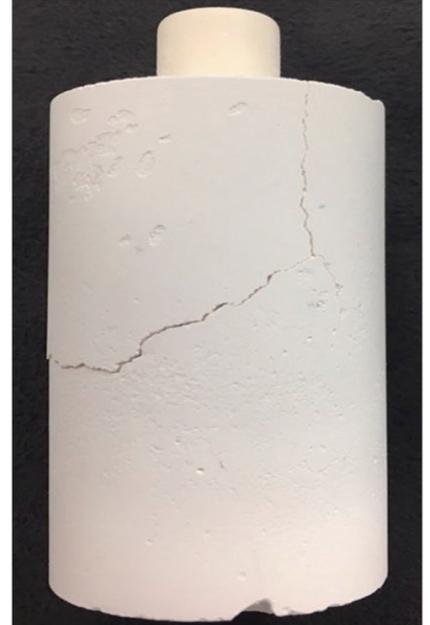
Case 7 Cracks of an investment ring during the pressing process

Investment ring cracks during the pressing process.

- 1) Residual investment material on the plunger surface.
- 2) The ring base may not be horizontal when pressed.
- 3) Some impact may be applied to the surface of the investment material.
- 4) Incorrect mixing ratio of investment material.
- 5) Insufficient curing time of investment material.

- Get rid of residual investment materials clearly on the plunger.
- Place the ring base surface horizontally to carry on the pressing.
- Be careful not to apply external impact to the ring.
- Check the pressure of the compressor in use.
- Get rid of moisture in the tank.

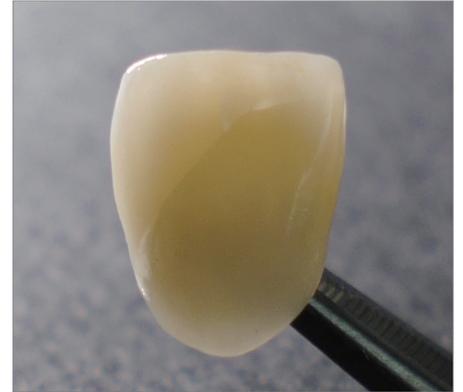
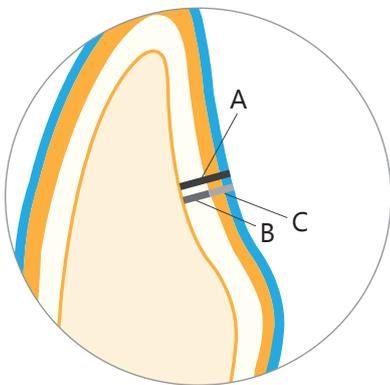
Case 1 Cracks after cut-back / layering technique

Cracks after cut-back/layering technique has been applied.

- 1) The guideline for minimum framework thickness may not been observed when building up veneering materials.
- 2) Fractures due to thermal shock and mismatched CTE between framework and veneering materials.
- 3) Thermal shock during polishing.
- 4) Compatibility issue with porcelain powders in use.
- 5) Degeneration of the framework due to the repetition of excessive firing over

- Layer thickness between framework and veneering powder must be strictly observed.
- Minimize thermal shock to the glass ceramic products.

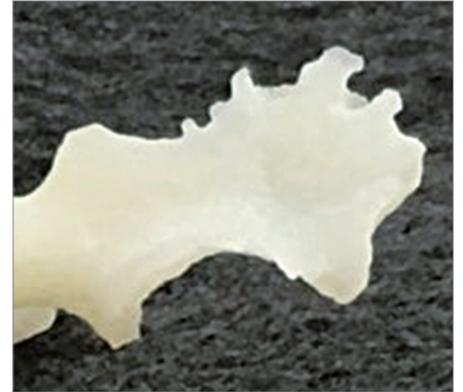
Case 2 Cracks on the margin part of the restorations

Cracks in the part of thin restorations after divesting

When alumina oxide is used in sand blasting.

- Glass bead with a particle size 25-50 micro is recommended to use for sand blasting.
- While the surface of the glass bead is round, alumina oxide particles are rough as the pictures below. Hence sand blasting with alumina oxide is not recommended for glass ceramic products.

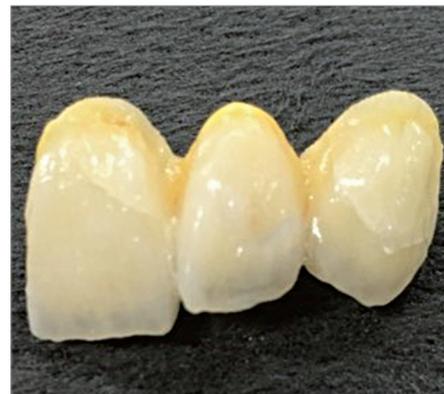
Case 3 Cracks during the the polishing process

Crack occurs during the polishing process.

- 1) When electroplated diamond burs were not used for polishing.
- 2) Thermal shock driven fractures caused by improper polishing.

- During the polishing process, be sure to use electroplated diamond burs for glass ceramics.
- Conduct your polishing job at a low working rate when you work with a hand piece and spray water on the surface of the restorations continuously to prevent thermal shock.
- During the polishing process, make sure that recommended minimum thickness of the restorations is well maintained.
- Do not trim the connecting part of the framework severely.

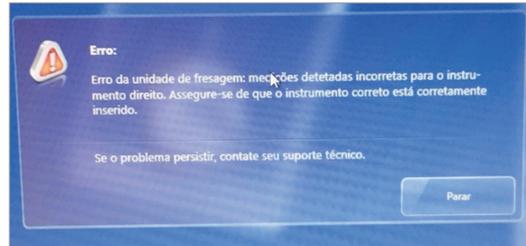
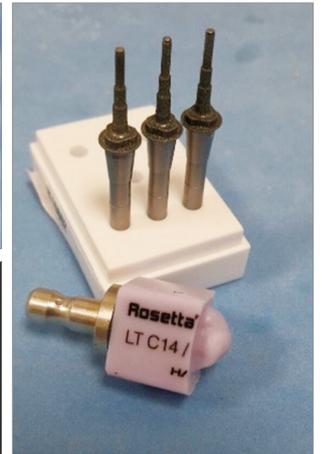
Case1 Issues for block products during the milling process

Error while milling the block.

1. Check specifics of the error message (screen captured image of error message from your customer is required).
2. Ask for the customer's opinion about which point seems to be probable cause of the error.
3. Check if the milling is performed thoroughly by the appropriate template setting.
4. Most issues during milling process is related to burs in use, so it is required to check the bur condition at the time of milling.
5. Check product Lot Number -> Conduct comparative test at manufacturer's side -> Share the result.
6. If the issue is directly related to the product, we (HASS) handle and provide appropriate service immediately. However, if it is the case of technical error of the machine used by the customer, we (HASS) recommend the customer get technical support from the machine manufacturer.

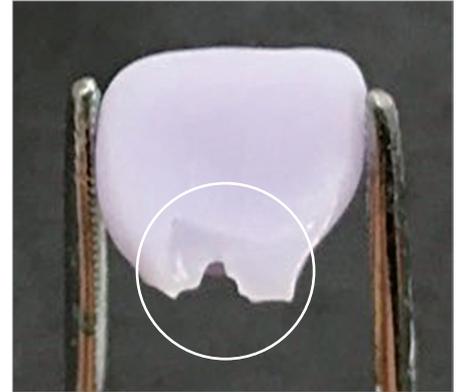
Case2 Chipping on the thin part of the prosthetics after milling

Chipping occurring after milling.

- 1) Surface of the tool may wear out too much.
- 2) The mix ratio of cutting fluid may not match the recommendation.
- 3) Thickness of the prosthetics may be tinner than the recommended guide.

- Check the replacement period of bur used in the work and current condition of surface wear-out.
- It is very important to use cutting fluid of the right amount recommended by the manufacturer.
Make sure to check the details on the cutting fluid you use.
- Be sure to check the minimum thickness of prosthetics recommended by HASS.

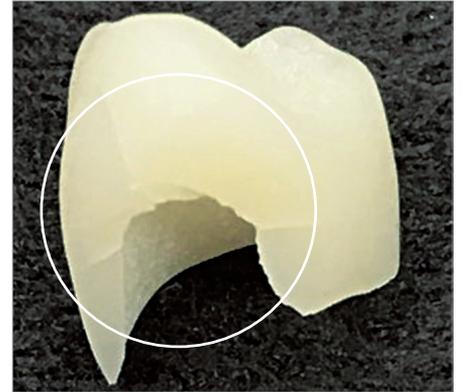
Case3 Crack on the SM product after crystallization

Crack on the SM product after crystallization.

- 1) Fractures caused by by the thermal shock during the crystallization process.
- 2) Thermal shock caused by external temperature difference or impacts after crystallization process.

- Be sure to use object fix for crystallization.
- Do not use metal pin but be sure to use ceramic pin for crystallization.
- Do not quench the prosthetics after crystallization.
- Do not pick up the hot prosthetics with metal tongs.
- Be aware that the air-conditioned room temperature is low in the summer, which may cause thermal shock to the prosthetics right after crystallization.
