Rosetta[®]

Troubleshooting Guide

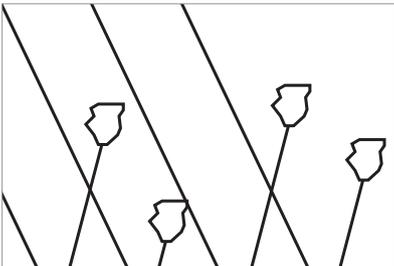
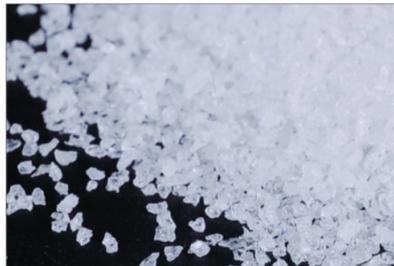
Alumina oxide

- Glass bead with a particle size 25-50 micro is recommended to use for sand blasting.
- While the surface of the glass bead is round, alumina oxide particles are rough as the pictures below. Hence sand blasting with alumina oxide is not recommended for glass ceramic products.
